Date: February 25, 2015
Inspector: Tim Menebroeker
Report example

Home Inspection Report

John Doe
Example
Address

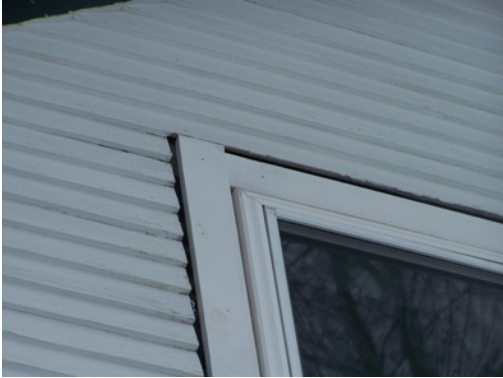
Some of the windows mainly on the upper south and east side of house have gaps around the trim and siding. These gaps should be sealed to prevent moisture from getting behind siding.

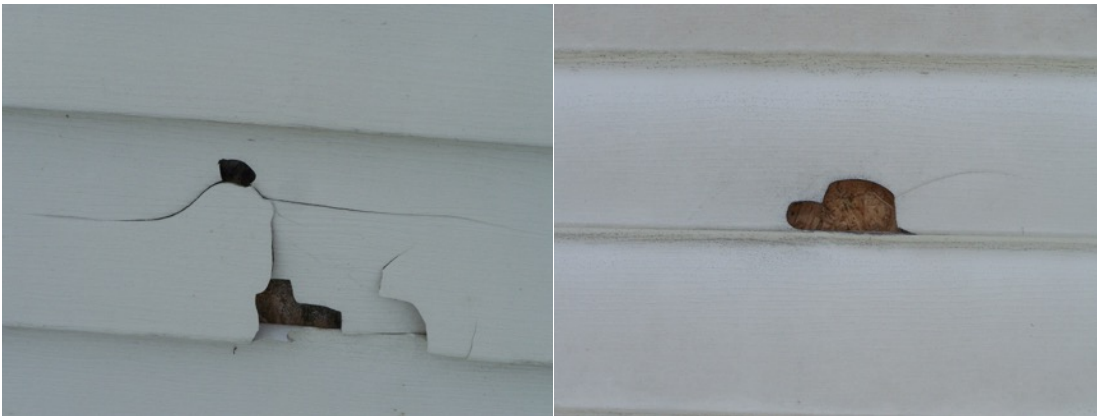
Garage has vinyl siding there are several places where the siding is cracked or has holes in the siding especially on the east and south sides. There doesn't appear to be a vapor barrier behind siding. These two conditions could lead to water penetrating the wood sheathing causing mold or rotting of the underlying wood.

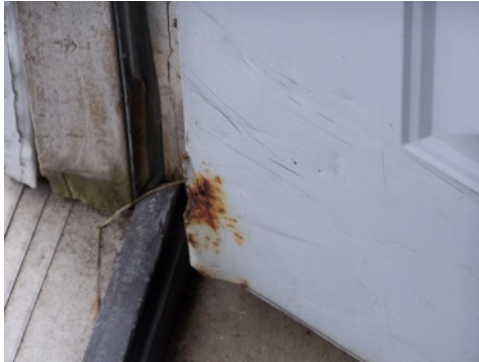
Service door showing signs of rust at bottom and has a few slashes in door which could allow water penetration and cause corrosion inside of door.

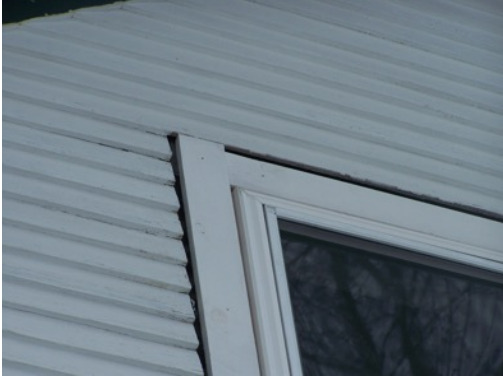
Some of the windows mainly on the upper south and east side of house have gaps around the trim and siding. These gaps should be sealed to prevent moisture from getting behind siding.

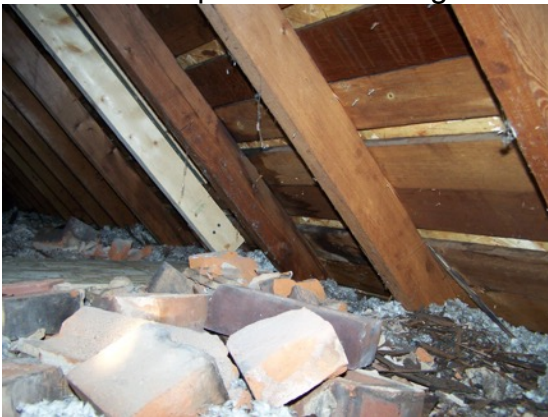
Rafters are of 2X4 construction with cross boards and osb (Orientated Strand Board) sheathing. There are signs of old water stains possibly where a chimney may have been removed. Noted some new 2x4's bricks lying in the area of this repair. No other signs of leaking were observed.

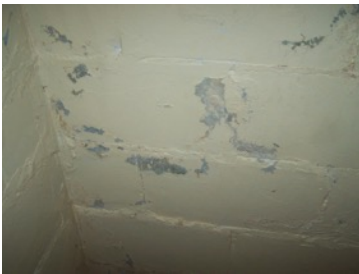
Some walls are finished and covered with dry wall brick wall on west side of basement shows peeling paint could be a result of water penetration.

Peeling paint on west wall could be from water penetration, some signs of past water penetration or water on floor noted on bottom of drywall on north rooms.

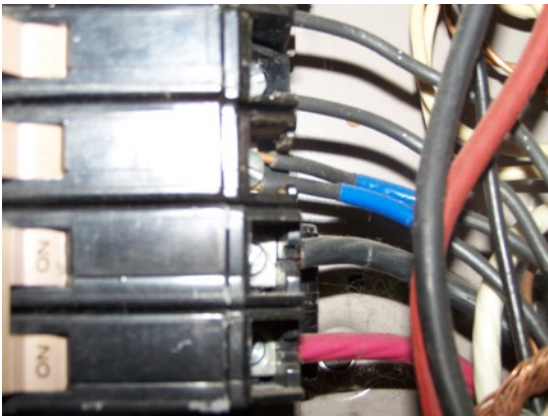
Noted two wires tied into one breaker this should be looked at by licensed electrician breaker switches are not designed to have more than one wire connected to them more could cause arcing and a possible fire hazard.
